INTERIOR PAINT CHIPS SAMPLING - BLDG 1 (1-201) EAST WALL

Rainier Commons Exterior Paint Removal Project

Daily Observations & Activity Report
(Note Date, Report # and Page # on each sheet)

Date: 1-30-2019

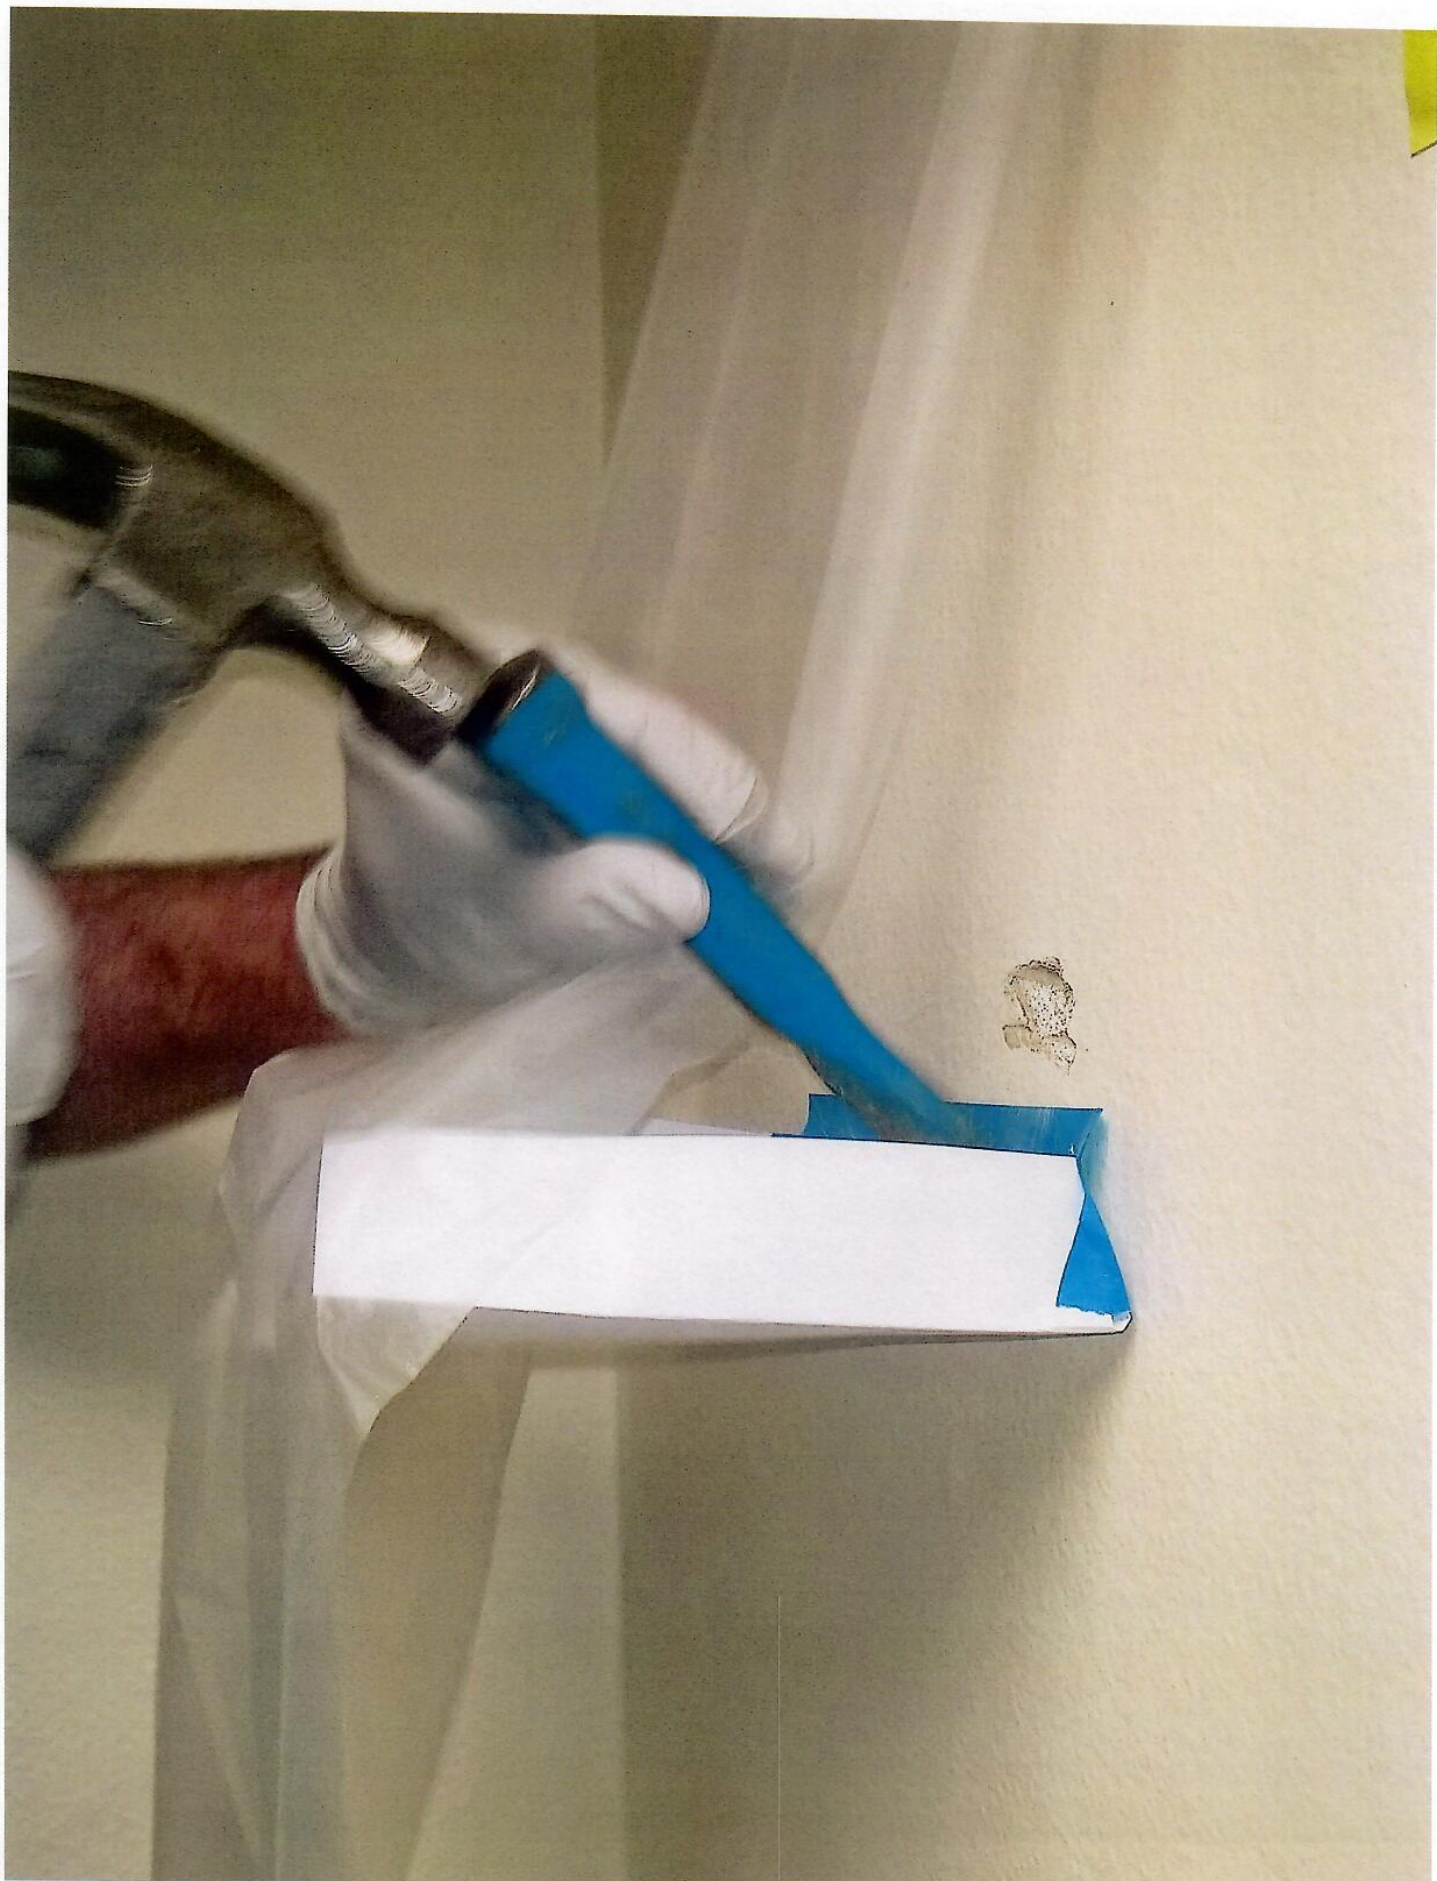
SAN
1

AT EACH SAMPLING LOCATION, A CLEAN, PAPER COLLECTION TRAY WAS TAPED TO THE WALL, DIRECTLY BELOW THE SPOT TO BE SAMPLED. A PLASTIC SHEET WAS THEN DRAPED ABOVE THE SAMPLING AREA, TO MINIMIZE SCATTERING PAINT CHIPS. (PLASTIC DRAPE WAS PULLED BACK DURING PHOTOGRAPHY, FOR CLARITY)

NORTH
